Re: 2022 Skaneateles Lake and Watershed Annual Report XLVIII

SKANEATELES LAKE AND WATERSHED 2022 ANNUAL REPORT VOLUME XLVIII

CITY OF SYRACUSE DEPARTMENT OF WATER WATER QUALITY MANAGEMENT

Rich Abbott Water Quality Management Department of Water City of Syracuse, New York April 2023

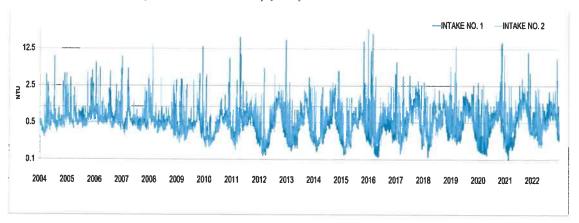
Figure 4 Monthly Counts of Turbidity >1 NTU at Intake 1, 2004-2022

Since monthly average data can mask spikes in turbidity, Figure 4 illustrates the number of occurrences with a daily maximum turbidity over 1 NTU for each month from 2004 – 2022. Daily maximum turbidity above 1 NTU was recorded on 44 days in 2022 at Intake #1. Twenty-nine of the 44 occurrences were between August and October in 2022 (Figure 4 & Table No. 9).

Both Table No. 9 and Figure 4 display the variance in the number of days with maximum turbidity greater than 1 NTU at Intake #1 from 2004 to 2022.

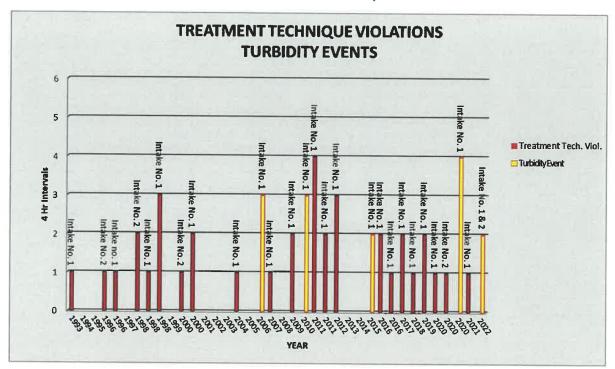
Figure 5 1993-2022 Treatment Technique Violations vs Turbidity Events

Refer to Figure 5 for TTV and Turbidity Events recorded since 1993. The Graph also displays the frequency that 5.0 NTU was exceeded (on a four-hour interval) during the TTV or Turbidity Event.

Note that in 2015, a Turbidity Event consisted of only two 5.0 NTU exceedances at four-hour intervals, comparable to numerous TTV's illustrated in the graph. However, because the intervals were at 8:00 pm and 12:00 am, the conditions set forth by NYSDOH defining a Turbidity Event (a series of consecutive days during which at least one turbidity measurement each day exceeded 5.0 NTU) was attained. The 2022 Turbidity Event was unique in that a TTV was recorded on Intake #2 on November 30 (4:00 am) during the Intake shutdown procedure. On December 1, Intake #1 exceeded 5.0 NTU at 12:00 pm resulting in two consecutive days with turbidity measurements exceeding 5.0 NTU.

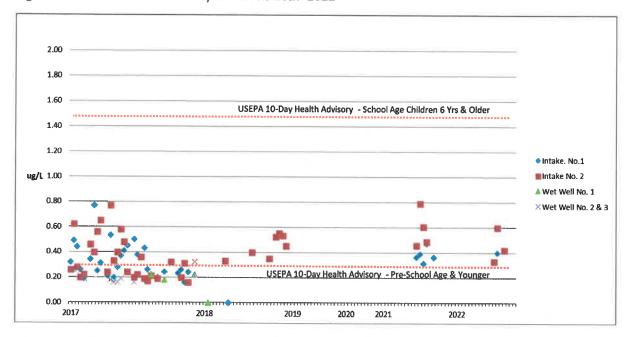
Figure 9 Skaneateles Lake Microcystin Levels 2017-2022

Algal blooms observed by Skaneateles Lake Watershed Protection staff in 2022 were small, localized and limited to near-shore areas Microcystin was detected in a raw water sample collected from Intake #1 on September 22, 2022. On September 19, 22, and October 3, 2022, microcystin was detected in raw water samples collected from Intake #2. Results ranged from 0.33 ug/L to 0.60 ug/L (Table 18).

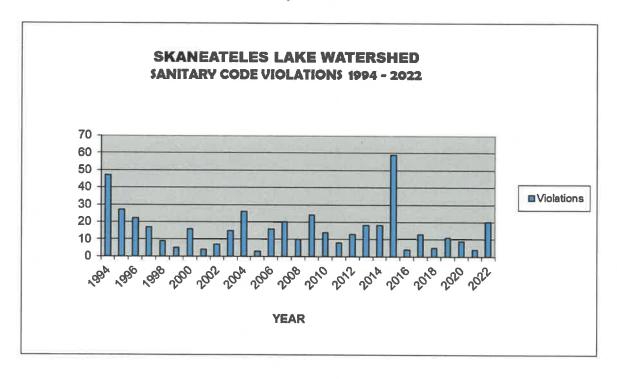
Figure 16 Skaneateles Lake Watershed Sanitary Code Violations 1994-2022

The enforcement of Sanitary Code violations is the responsibility of the respective county health departments. Alleged violators are issued a Violation Notice from the City of Syracuse and given five working days to reply and declare their intent to affect the necessary repairs. If there is no response, or if the property owner refuses to abate the problem, the violation is forwarded to the respective county health department for enforcement. Sanitary Code violations identified by Watershed Inspectors since 1994 are shown in Figure 16.
